LOCATION OF INZALACO PARCEL (OUTLINED IN GREEN) TO HEREFORD ARMY AIRFIELD SITE
 (extracted from USACE May 2012)

PHOTOGRAPHIC LOG OF SITE VISIT

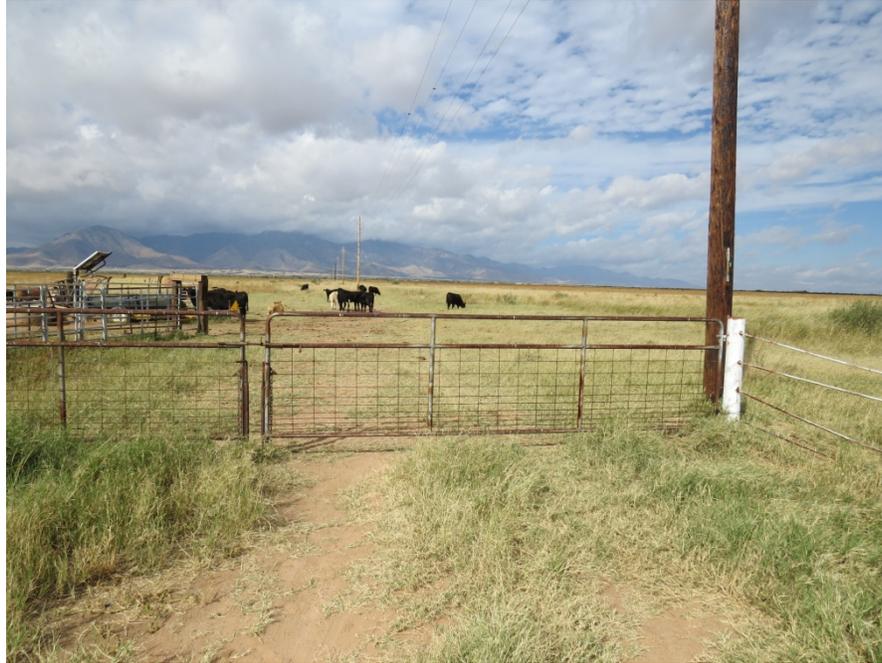
Photograph #1. The entrance gate onto the property is located on the east side of the Section looking west, approximately one-half mile to the south of the junction of Three Canyons Road and Palominas Road. SSVEC power transmission line transits the property on east-west line.

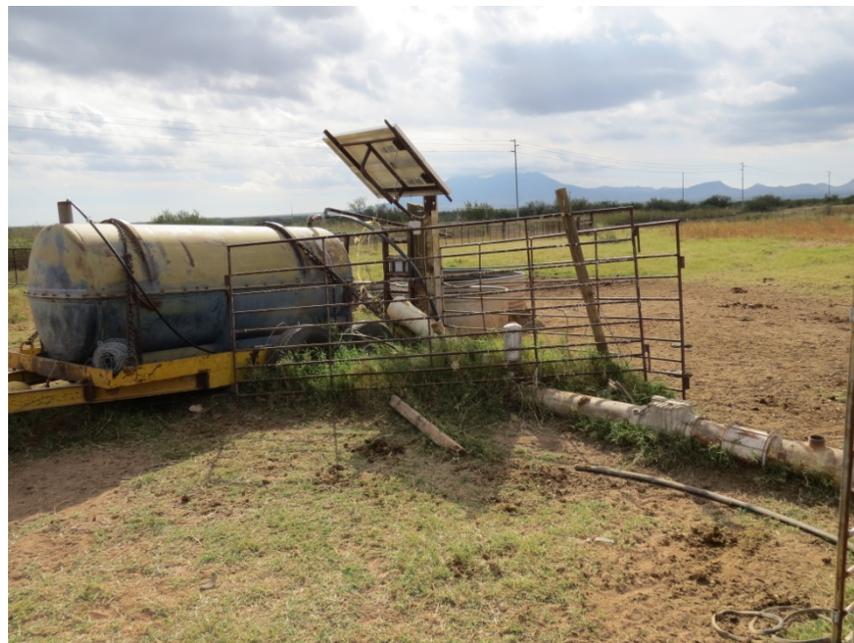
Photograph #2. The first wellhead is located closely adjacent to the entrance gate. There is a submersible pump in the well head that pumps water to the water wagon for distribution to three livestock tanks. View is looking to the southeast from the northwest side of the wellhead.

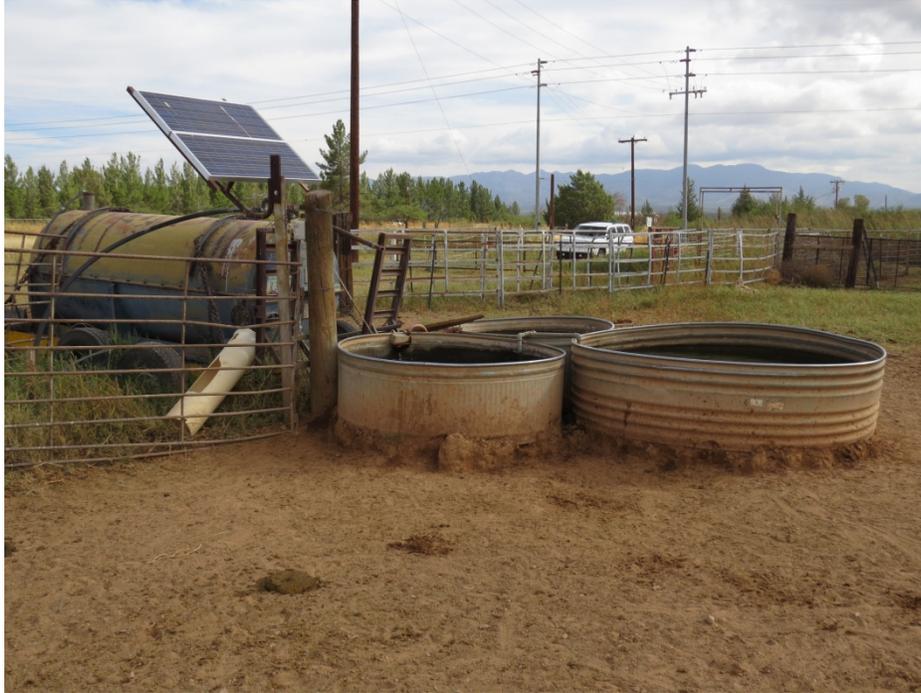
Photograph #3. Three livestock tanks are adjacent to the south of the first wellhead. Solar panel provides power for water pump. View is to the east northeast.

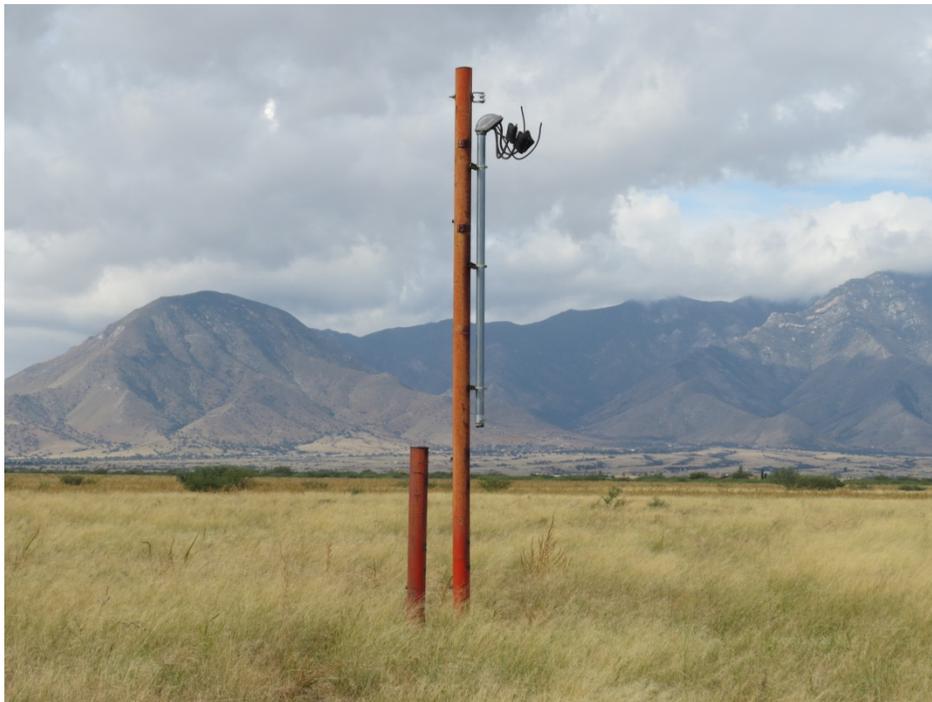
Photograph #4. Old metal power pole and a metal post (both painted orange) are located to the south of the SSVEC transmission line. View is to the west. This appears to have taken power from the SSVEC transmission line for use in pumping groundwater.

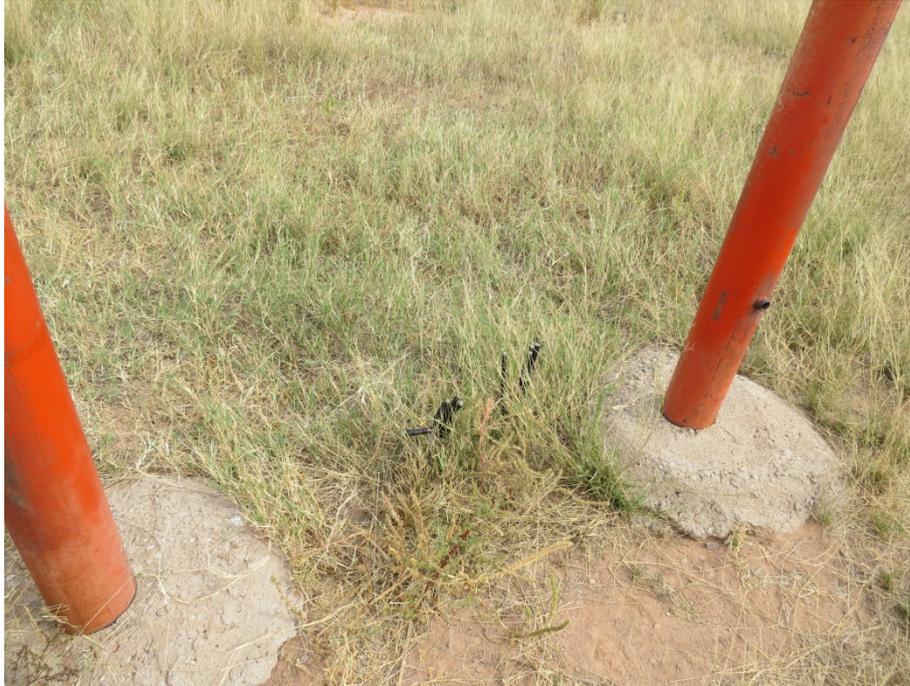
Photograph #5. Power lines to the wellheads and then to the center pivots were located in the ground between the two orange poles shown in Photograph #4 above.

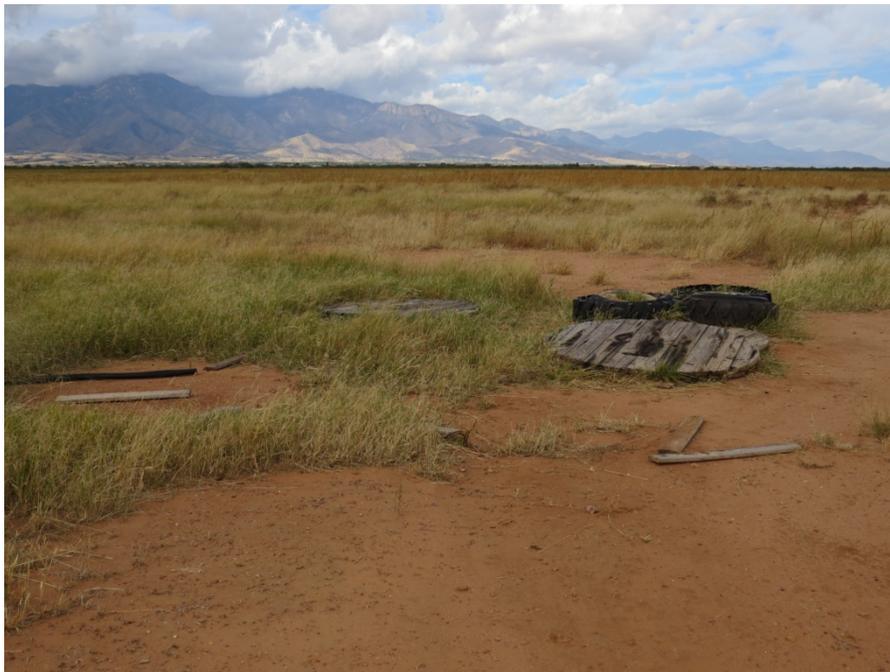
Photograph #6. Old implement tires and rims and a cable spindle are located outside the pivot area in the grass of the southeast quarter of the northwest quarter of the section.

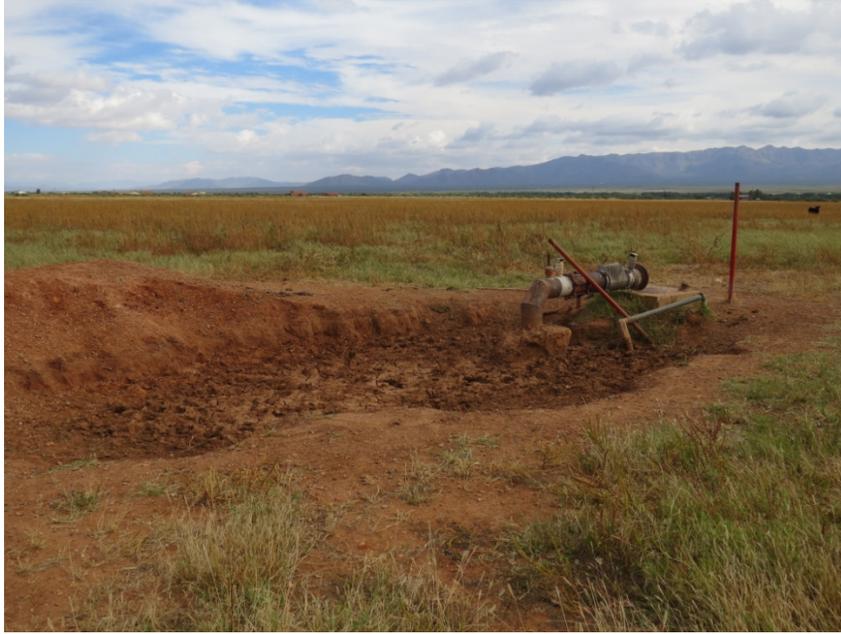
Photograph #7. Photograph of agricultural well distribution system for agricultural well in northeast quarter section, looking east northeast. System remains in place. Precipitation accumulates in the pit that livestock use when grazing. Electrical power was in pipe laying down to the south of the distribution system.

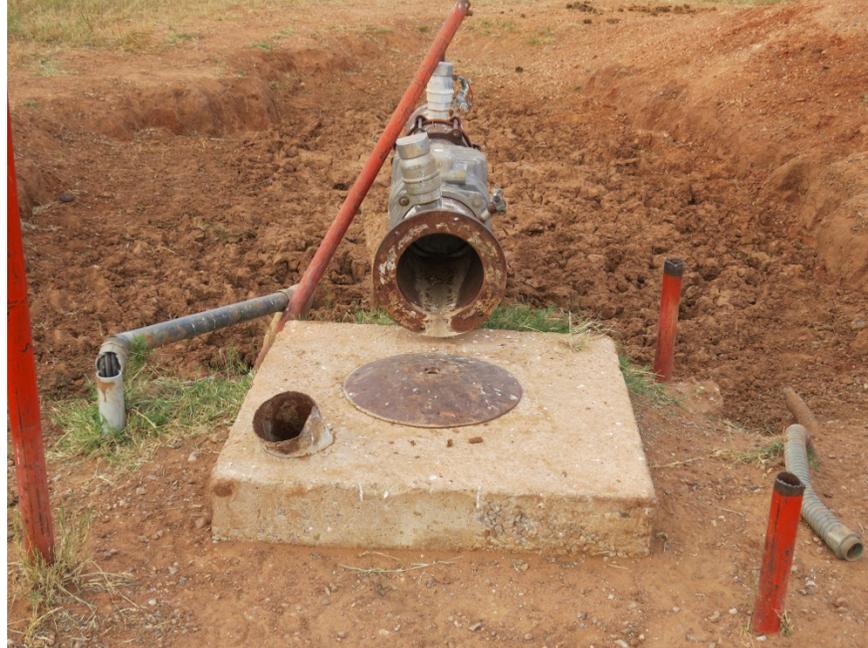
Photograph #8. Wellhead and vent pipe in concrete pad surrounding wellhead for the agricultural well in the northeast quarter section, looking west. A metal plate has been placed over the wellhead. Vent pipe is uncovered but is filled with soil

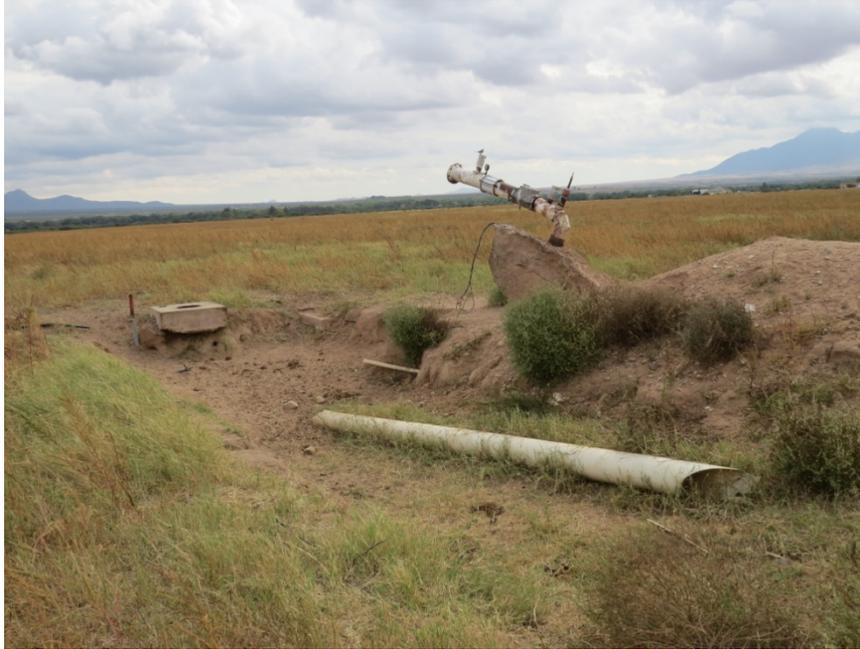
Photograph #11. The photograph of the excavated distribution system for the agricultural well in the southeast quarter section is taken looking to the southeast. Eight inch PVC piping was used to convey water to center pivots.

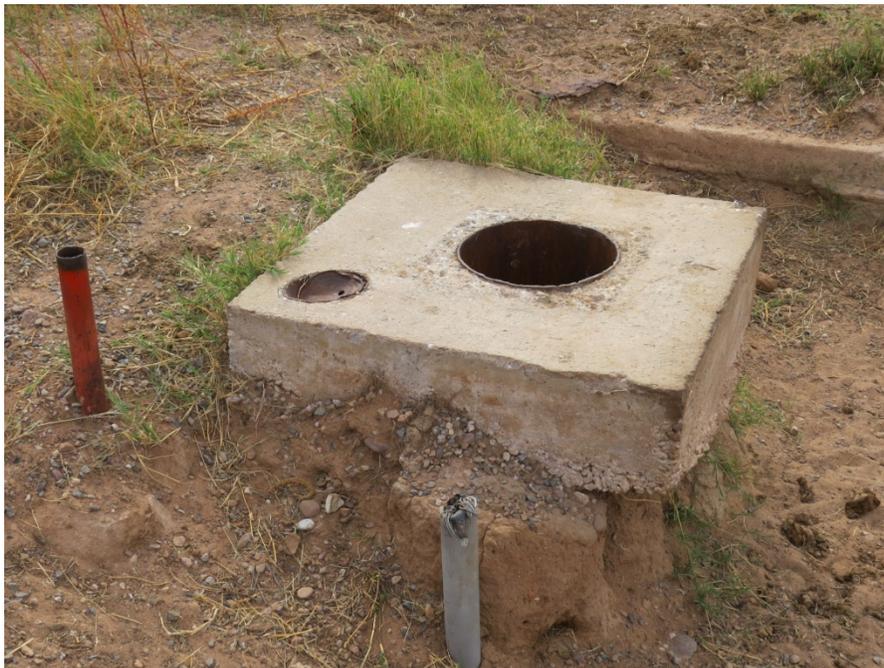
Photograph #12. This photograph of the wellhead for the agricultural well in the southeast quarter of the section, looking to the south southeast. Wellhead is open, with vent pipe covered but in poor condition. Electrical cable pipe is in the foreground.

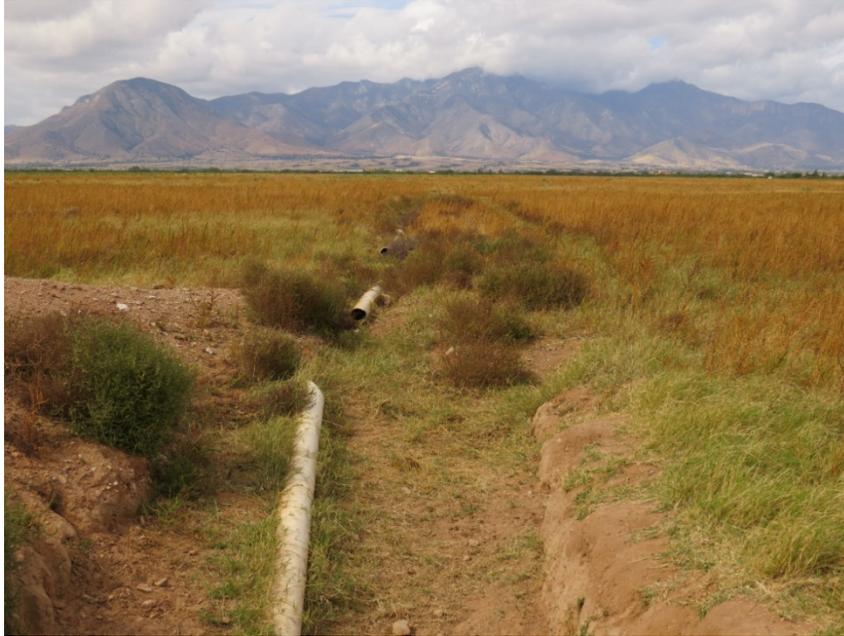
Photograph #13. This photograph is taken from the wellhead for the agricultural well in the southeast quarter of the section, looking west to the Huachuca Mountains. There is an open ditch in the area with remnants of the eight inch PVC pipe in the bottom.
