ARIZONA COUNTIES INSURANCE POOL

Photographic Log and Hazard Analysis Report

Site Location: Willcox Animal Shelter, 1525 E. Stewart, Willcox, AZ

11-Mar-15

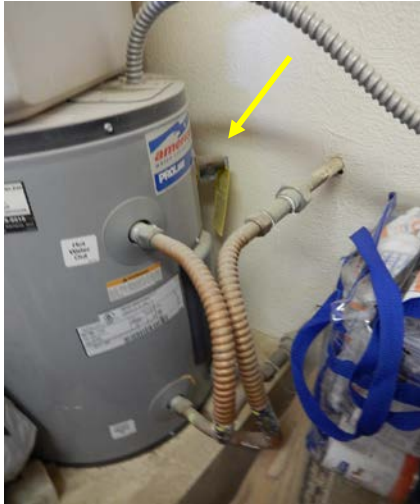
Photo Description or Location: Hot water closet

Hazard: Water damage

Hot water relief valve drain line should be vented outside building or into drain.

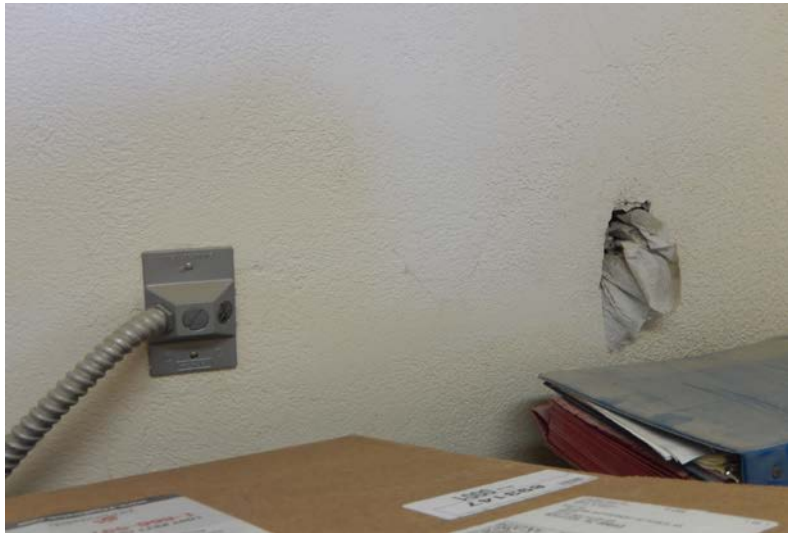
Photo Description or Location: Office area

Hazard: Smoke damage

Wall breach should be sealed.

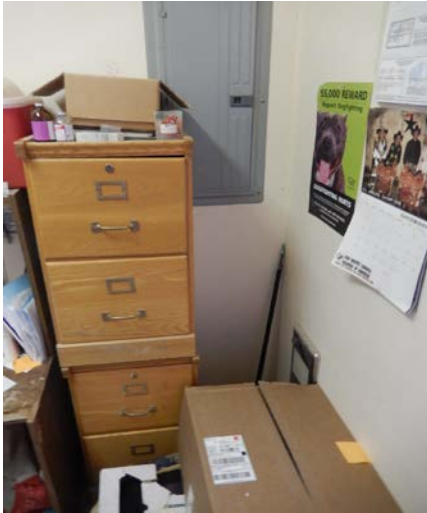
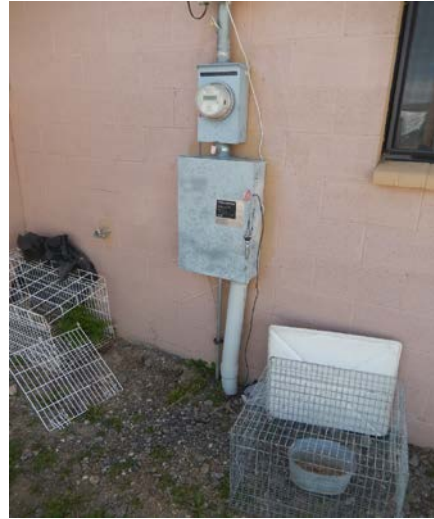
Photo Description or Location: Office area and building exterior

Hazard: Fire damage, inadequate emergency preparedness

No object should be stored/placed within three feet front and around electrical panel.

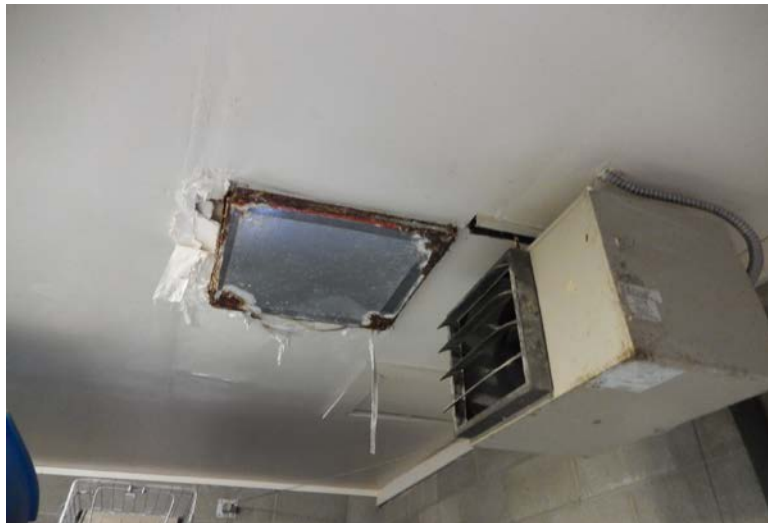
Photo Description or Location: Kennels

Hazard: Water damage, mold

Evident water damage to ceiling; roof above kennels should be repaired.

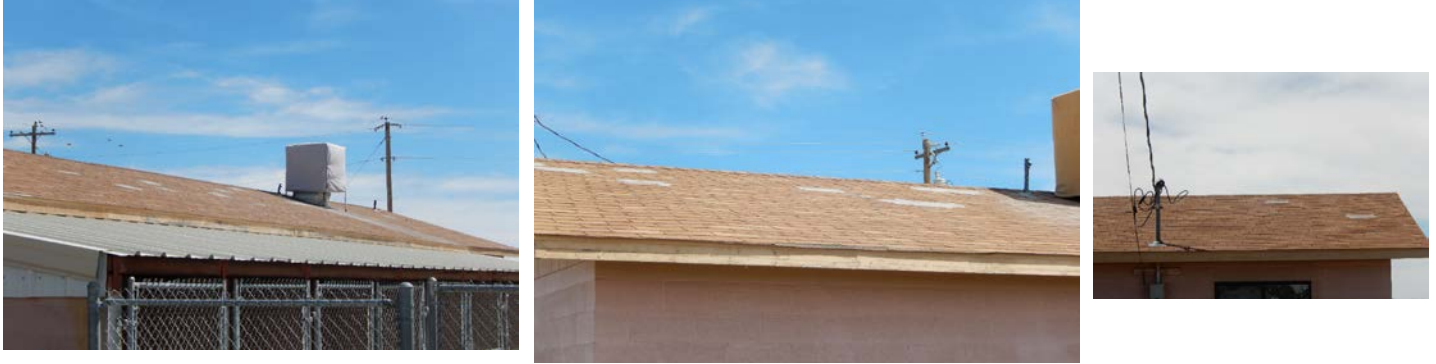
Photo Description or Location: Roof

Hazard: Water damage, mold

Damaged and missing roofing tiles should be replaced, especially on building's west side.

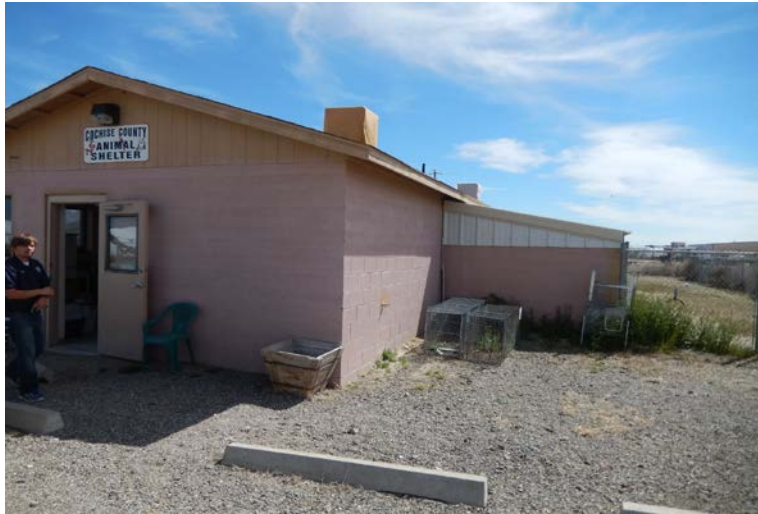
Photo Description or Location: Building wood exterior

Hazard: Water damage, mold

Wooden portions of building's exterior need scraped and repainted.
