Three Canyons/Palominas Parcel, AZ Conservation Easement Documentation Report

Date: October 22nd, 2013

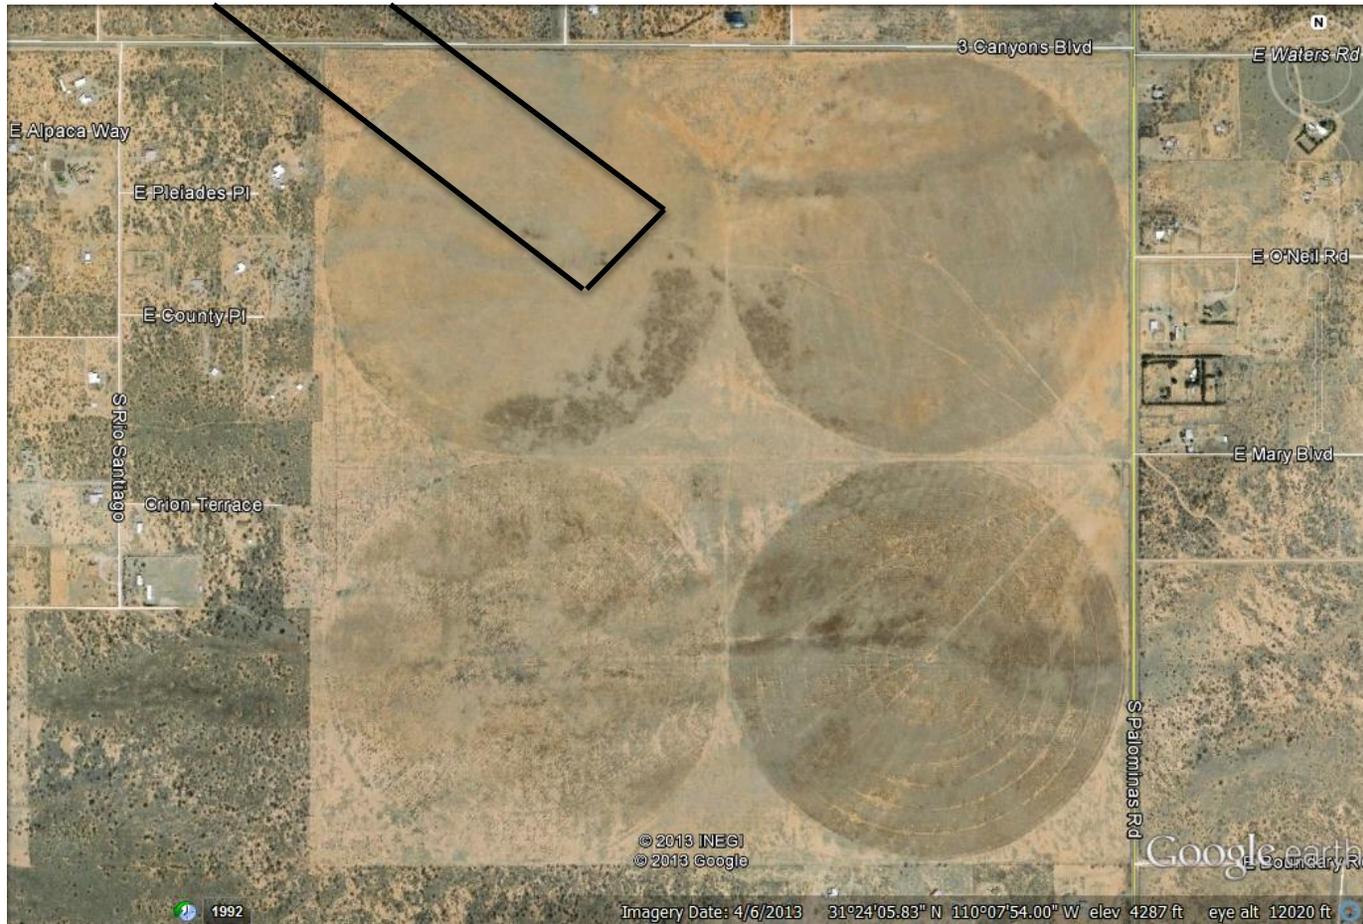
EXHIBIT 4

There is very little debris on the Property with the exception of some old tires and rims and wood from cable spools. Although the aerial photograph shown in Exhibit 4 indicates the approximate location of the former runway in the northwestern quarter of the Property, there is little on the ground to distinguish the area from its surroundings.

Approximate Location of Hereford Army Airfield Runway within Three Canyons/Palominas Parcel.

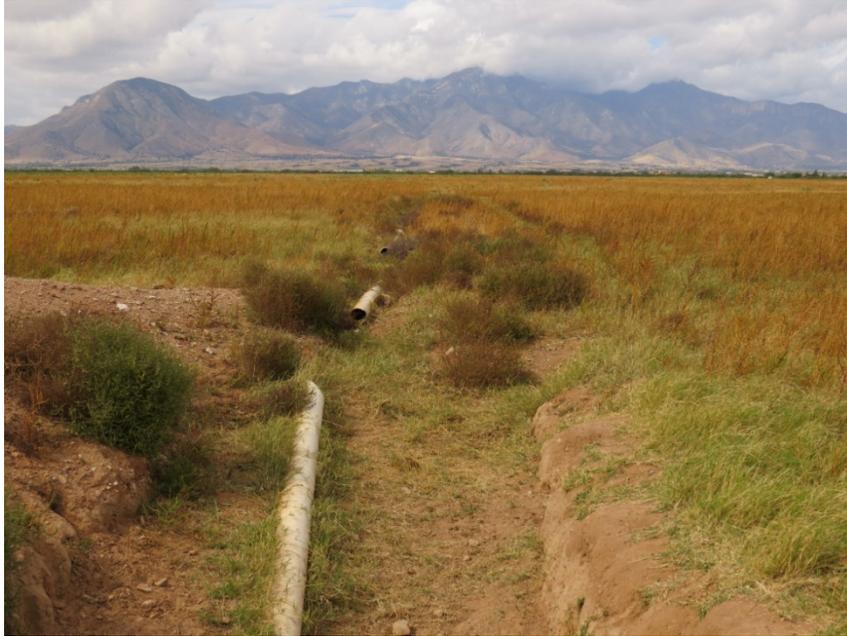
Photograph #13. This photograph is taken from the wellhead for the agricultural well in the southeast quarter of the section, looking west to the Huachuca Mountains. There is an open ditch in the area with remnants of the eight inch PVC pipe in the bottom.
