LOCATION OF INZALACO PARCEL (OUTLINED IN GREEN) TO HEREFORD ARMY AIRFIELD SITE
 (extracted from USACE May 2012)

PHOTOGRAPHIC LOG OF SITE VISIT

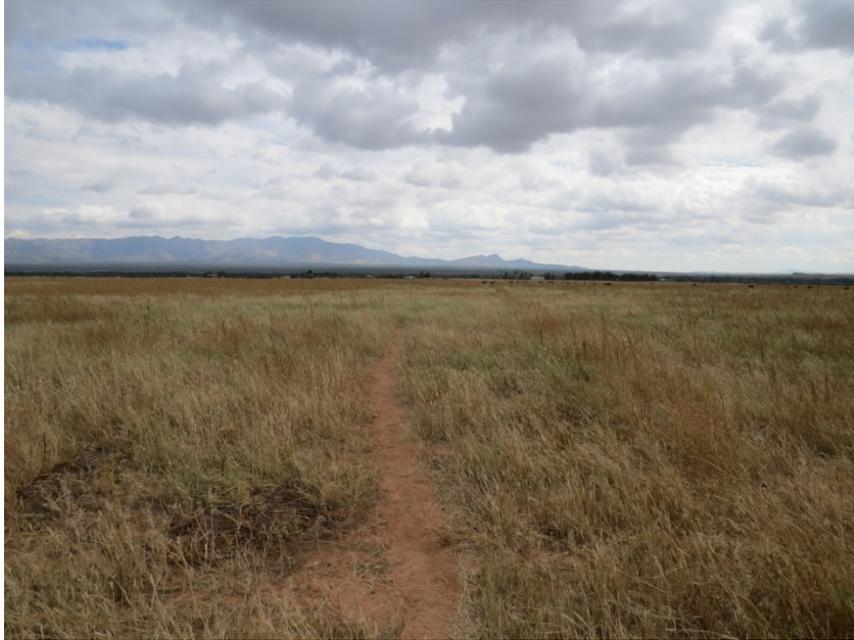
Photograph #9. This grasslands photograph was taken from location halfway between pivot systems for northeast and northwest quarters of the section looking east to the Mule Mountains..

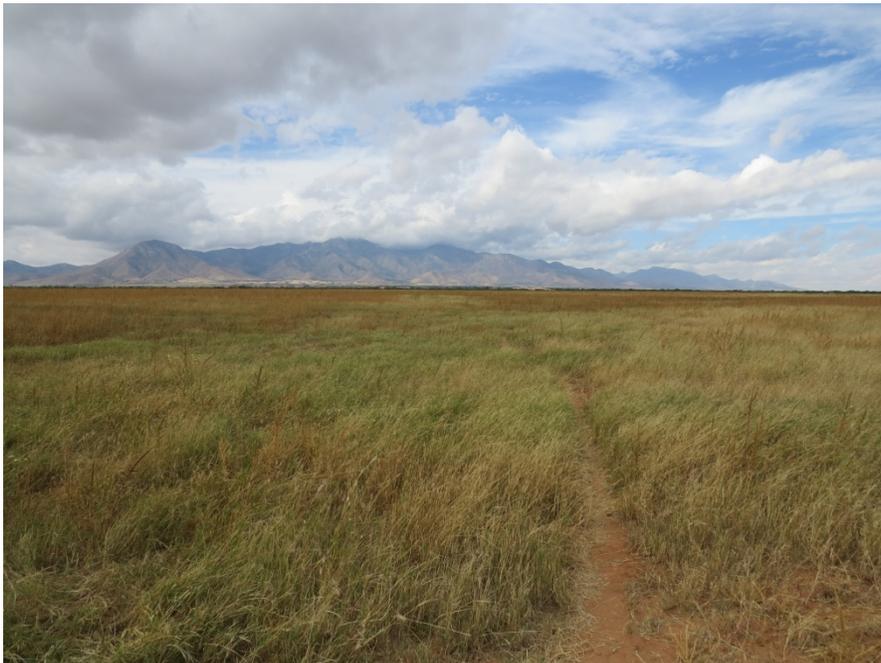
Photograph #10. This grasslands photograph was taken from location halfway between pivot systems for northeast and northwest quarters of the section looking west to the Huachuca Mountains..

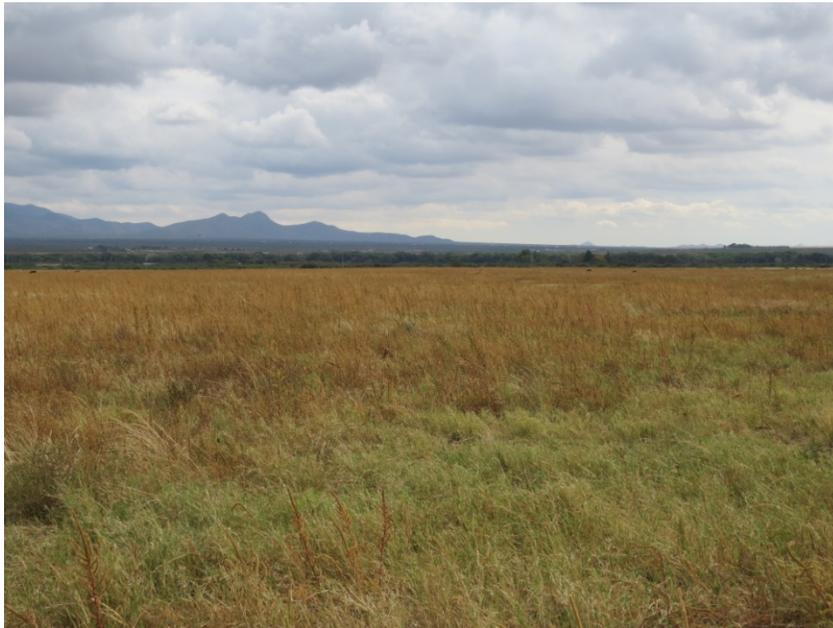
Photograph #14. This photograph is taken from the wellhead for the agricultural well in the southeast quarter of the section, looking east to the Mule Mountains.
